Creative New Ways In Which Moisture Is Damaging Our Buildings

Gary Proskiw, P. Eng.; Proskiw Engineering Ltd.

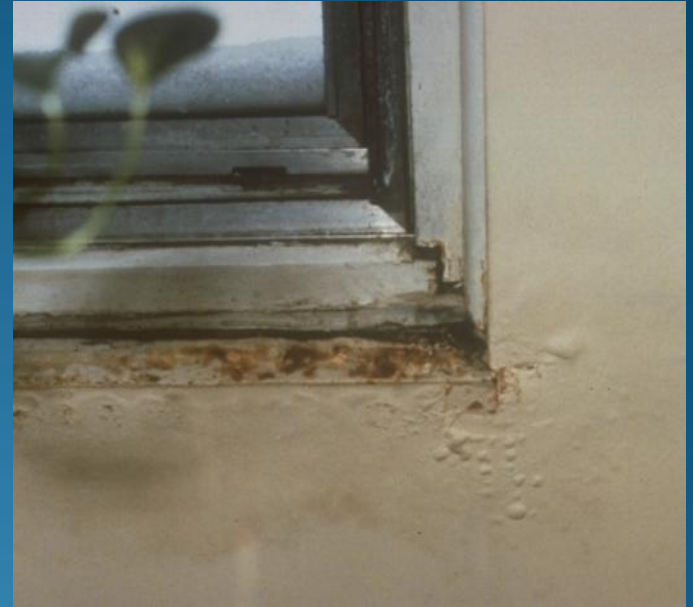
Surface Condensation

- Occurs when air is cooled to its “dew point” temperature; the air is saturated and can not hold more water vapour.
- There are two types of condensation:
 1. Surface condensation (usually a minor problem).
 2. Interstitial condensation (usually a major problem this is the building science equivalent of cancer).

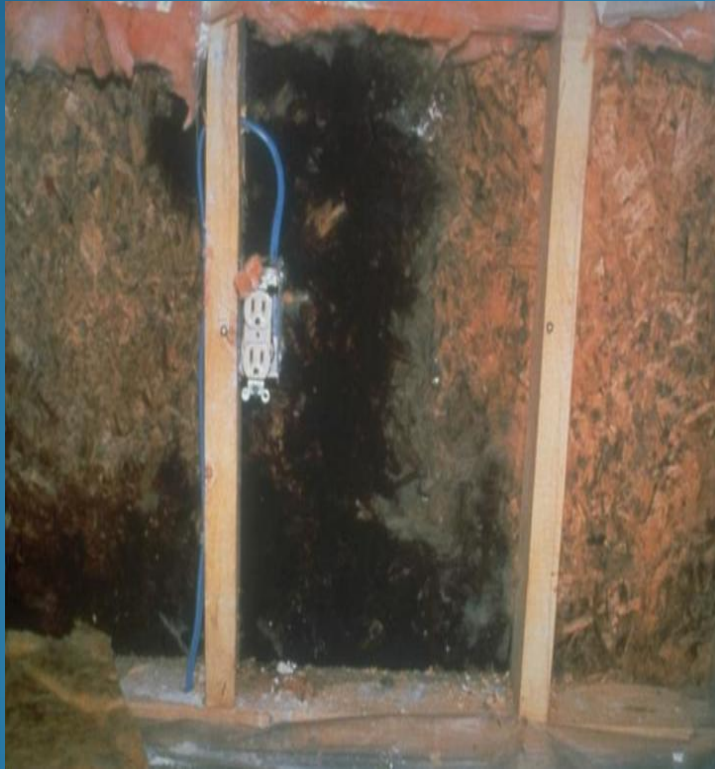
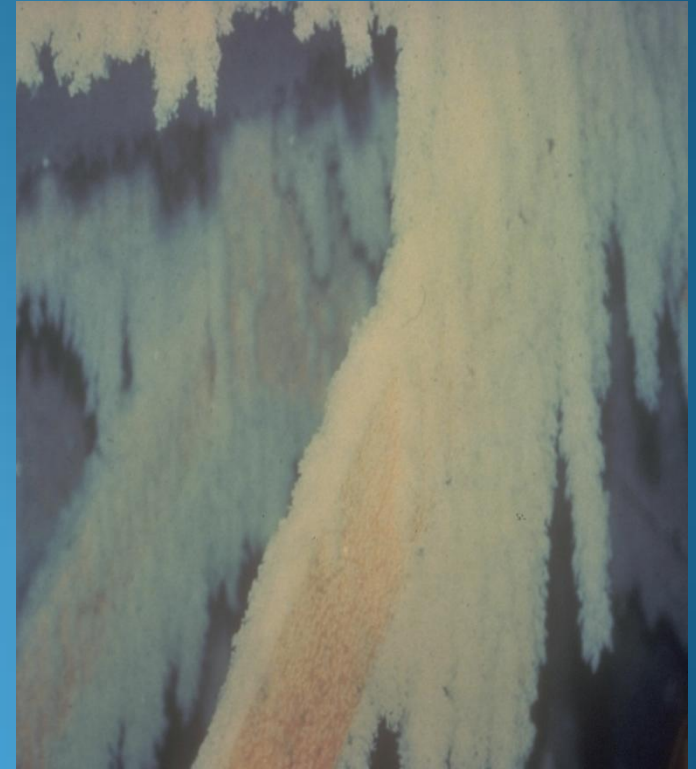
The Major Threat Which Moisture Poses To The Building Envelope Is From Air Exfiltration / Interstitial Moisture Deposition

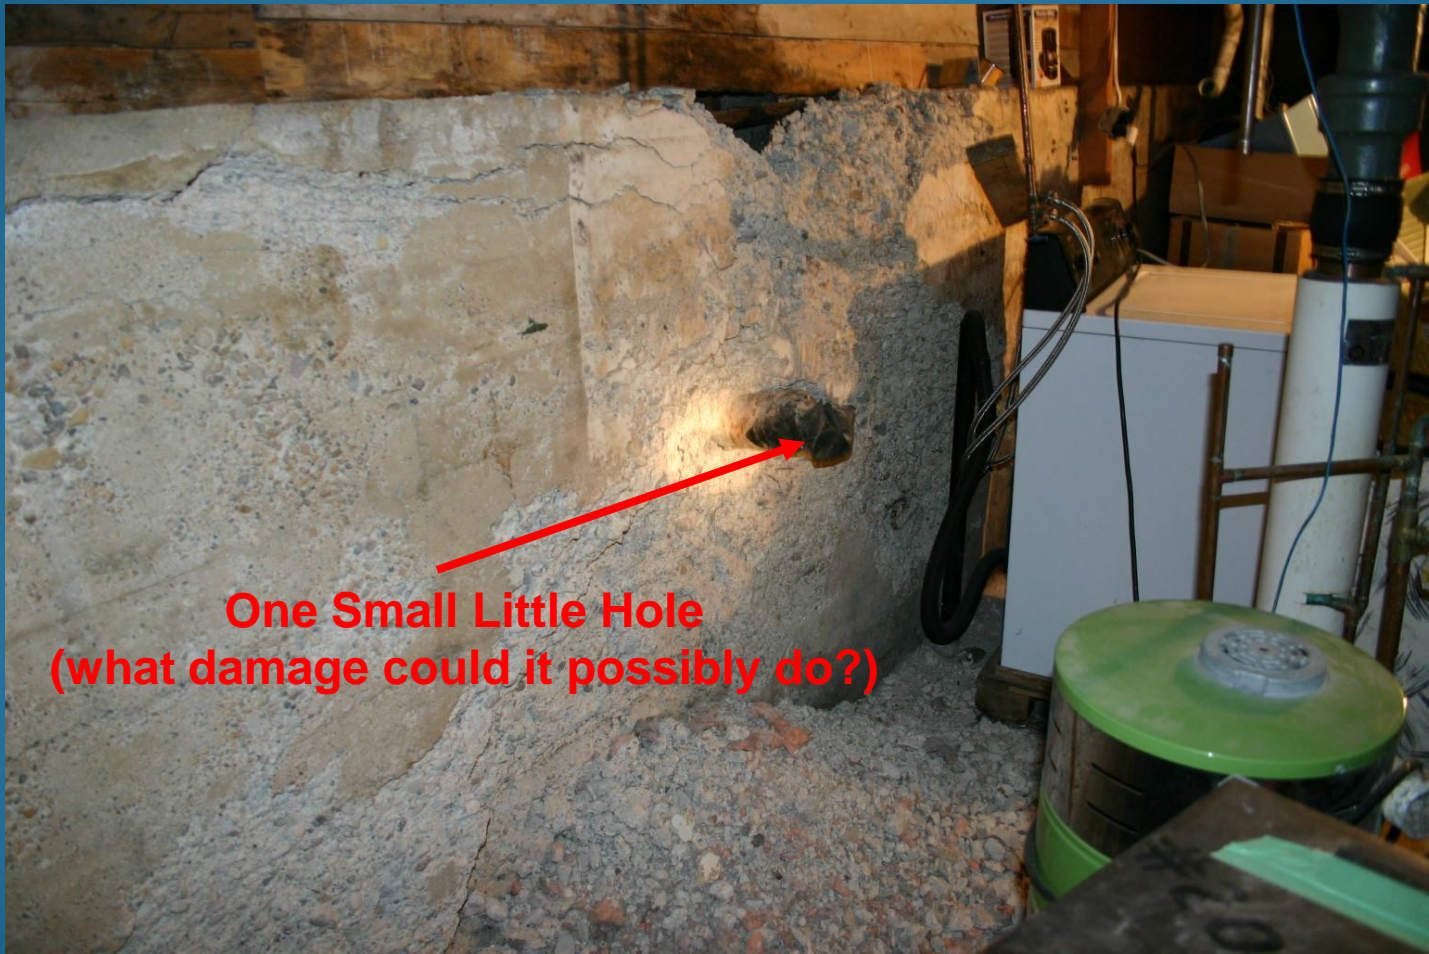
**One Small Little Hole
(what damage could it possibly do?)**

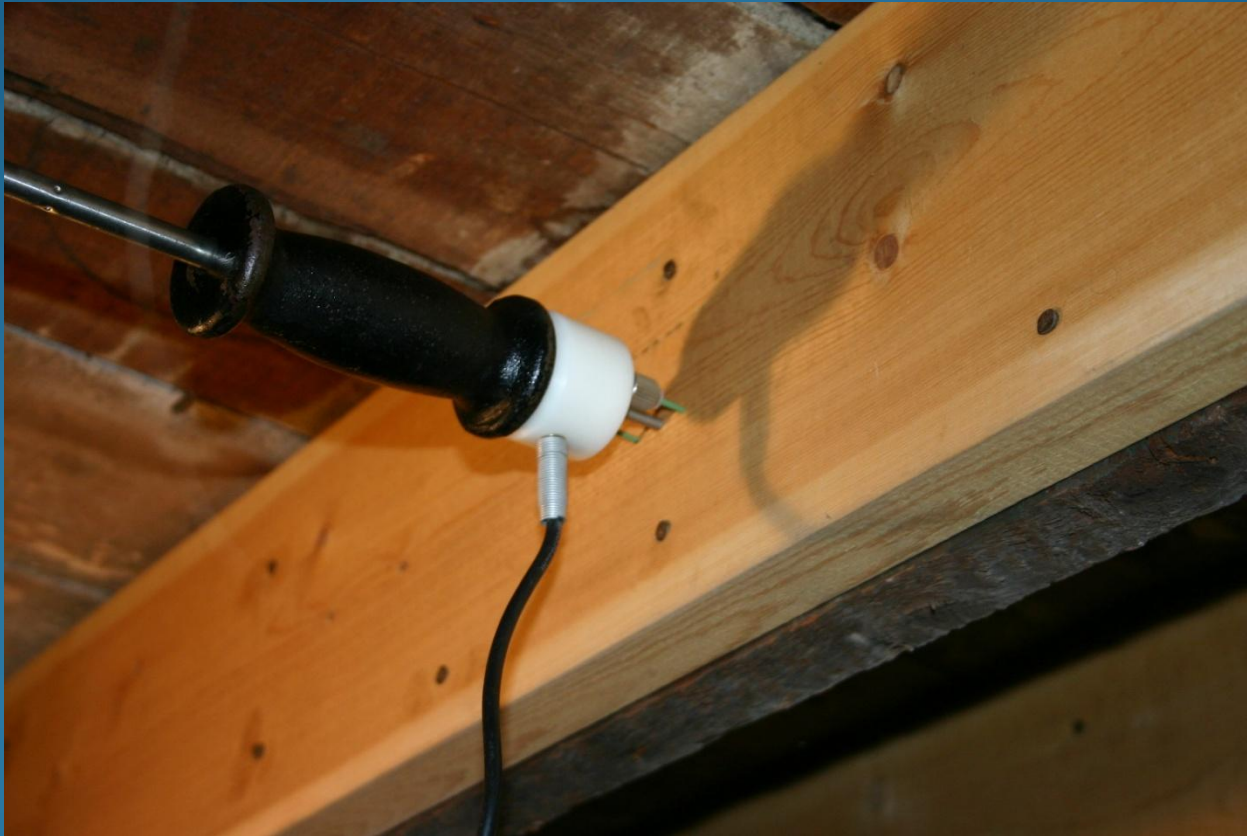
Long-Term R/H Test

Solution is to use existing, exposed wood (e.g. floor joists) as a Duff Gauge to measure the EMC (Equilibrium Moisture Content) – by measuring the EMC, we can determine the long-term R/H of the air

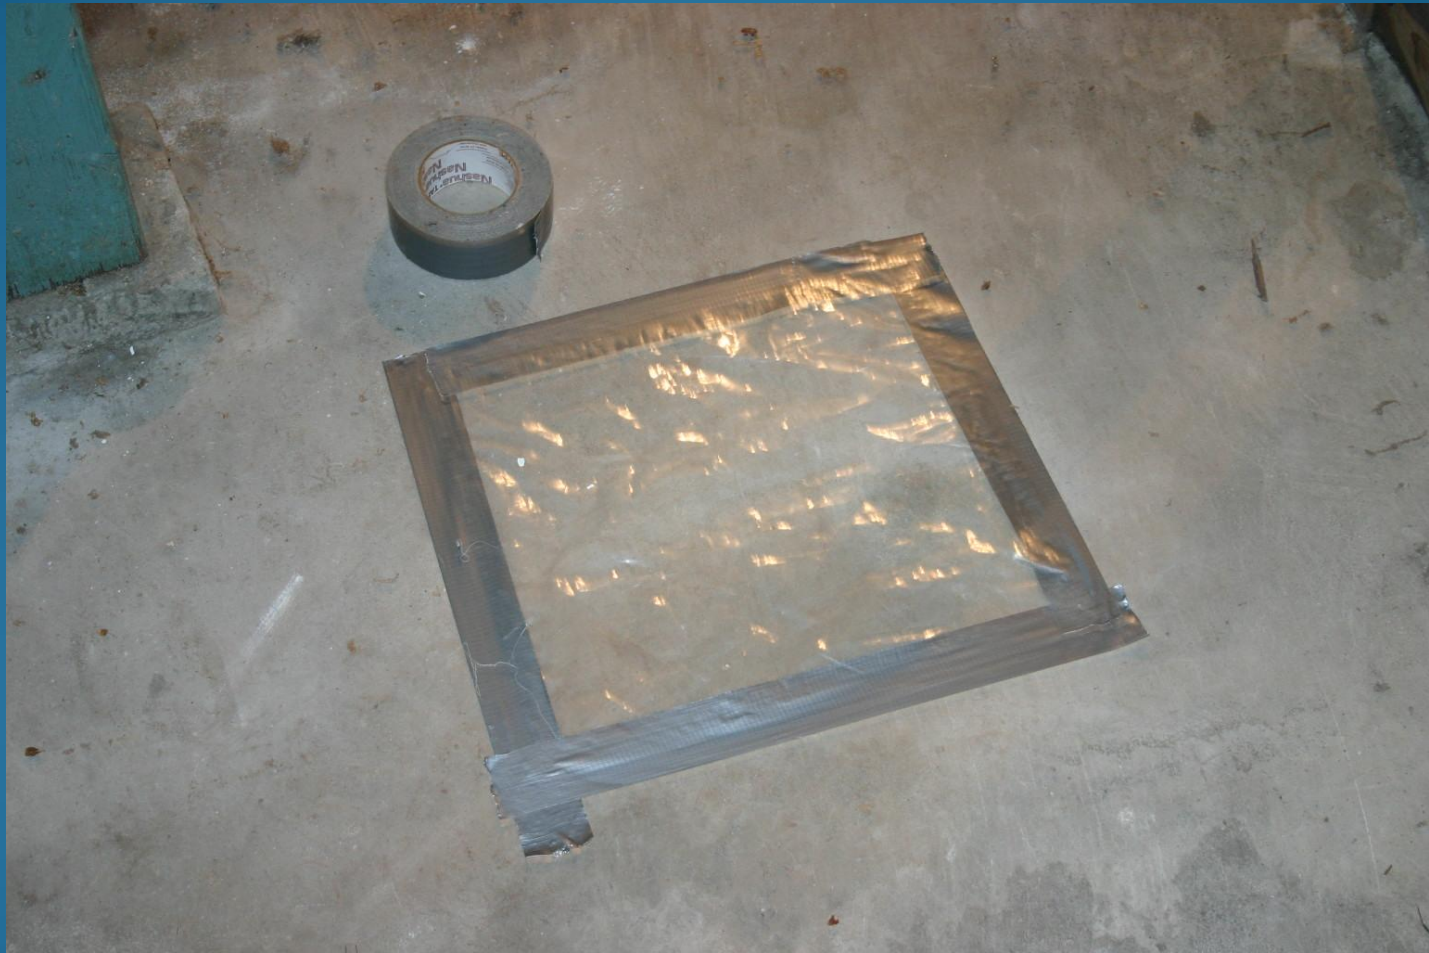
Capillary Transport Test

- Determines whether moisture is moving through the slab by capillary action
- Tape 1' x 1' pieces of poly to the slab (4 or 5 per house)
- Leave for two or three days
- If moisture is present under the poly, then moisture is moving through the slab by capillary action
- If moisture is present on top of the poly, then it originated inside the house and condensed on the poly

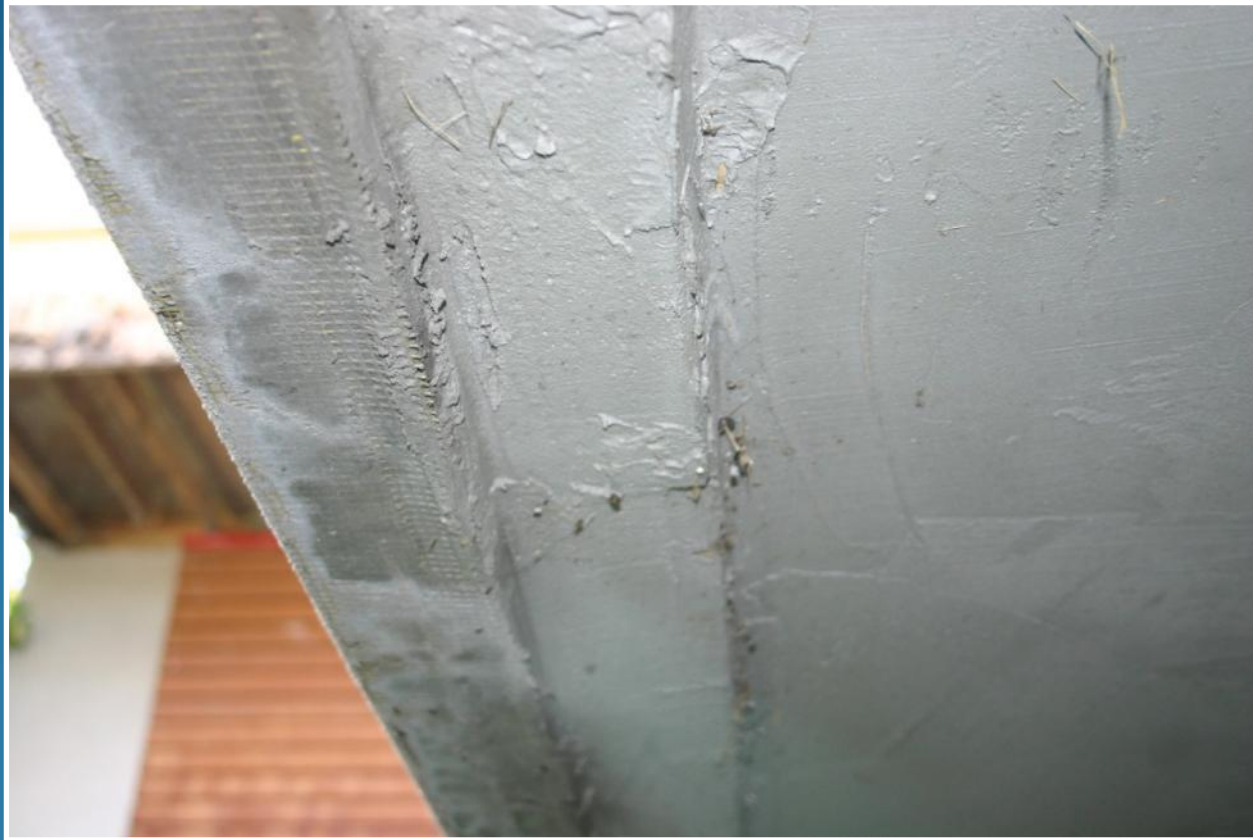
Will This Provide Adequate Drainage???

No!

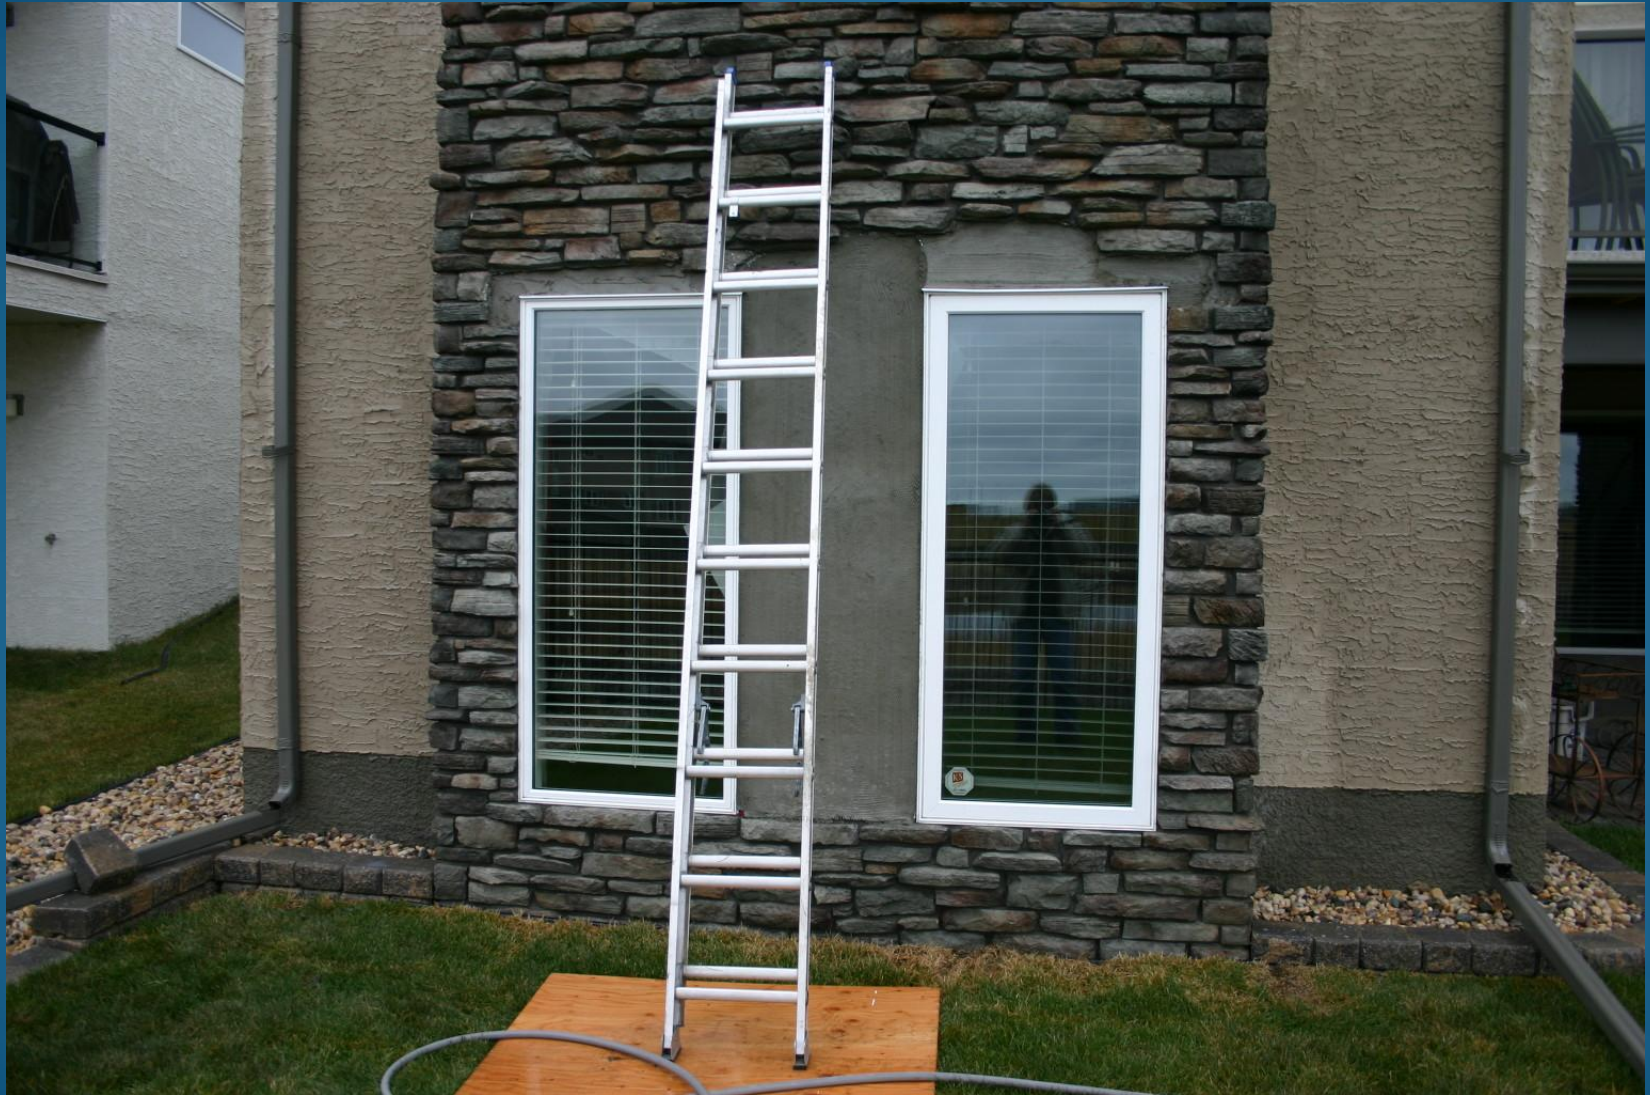
Cultured Stone Finish – Without A Rain Screen

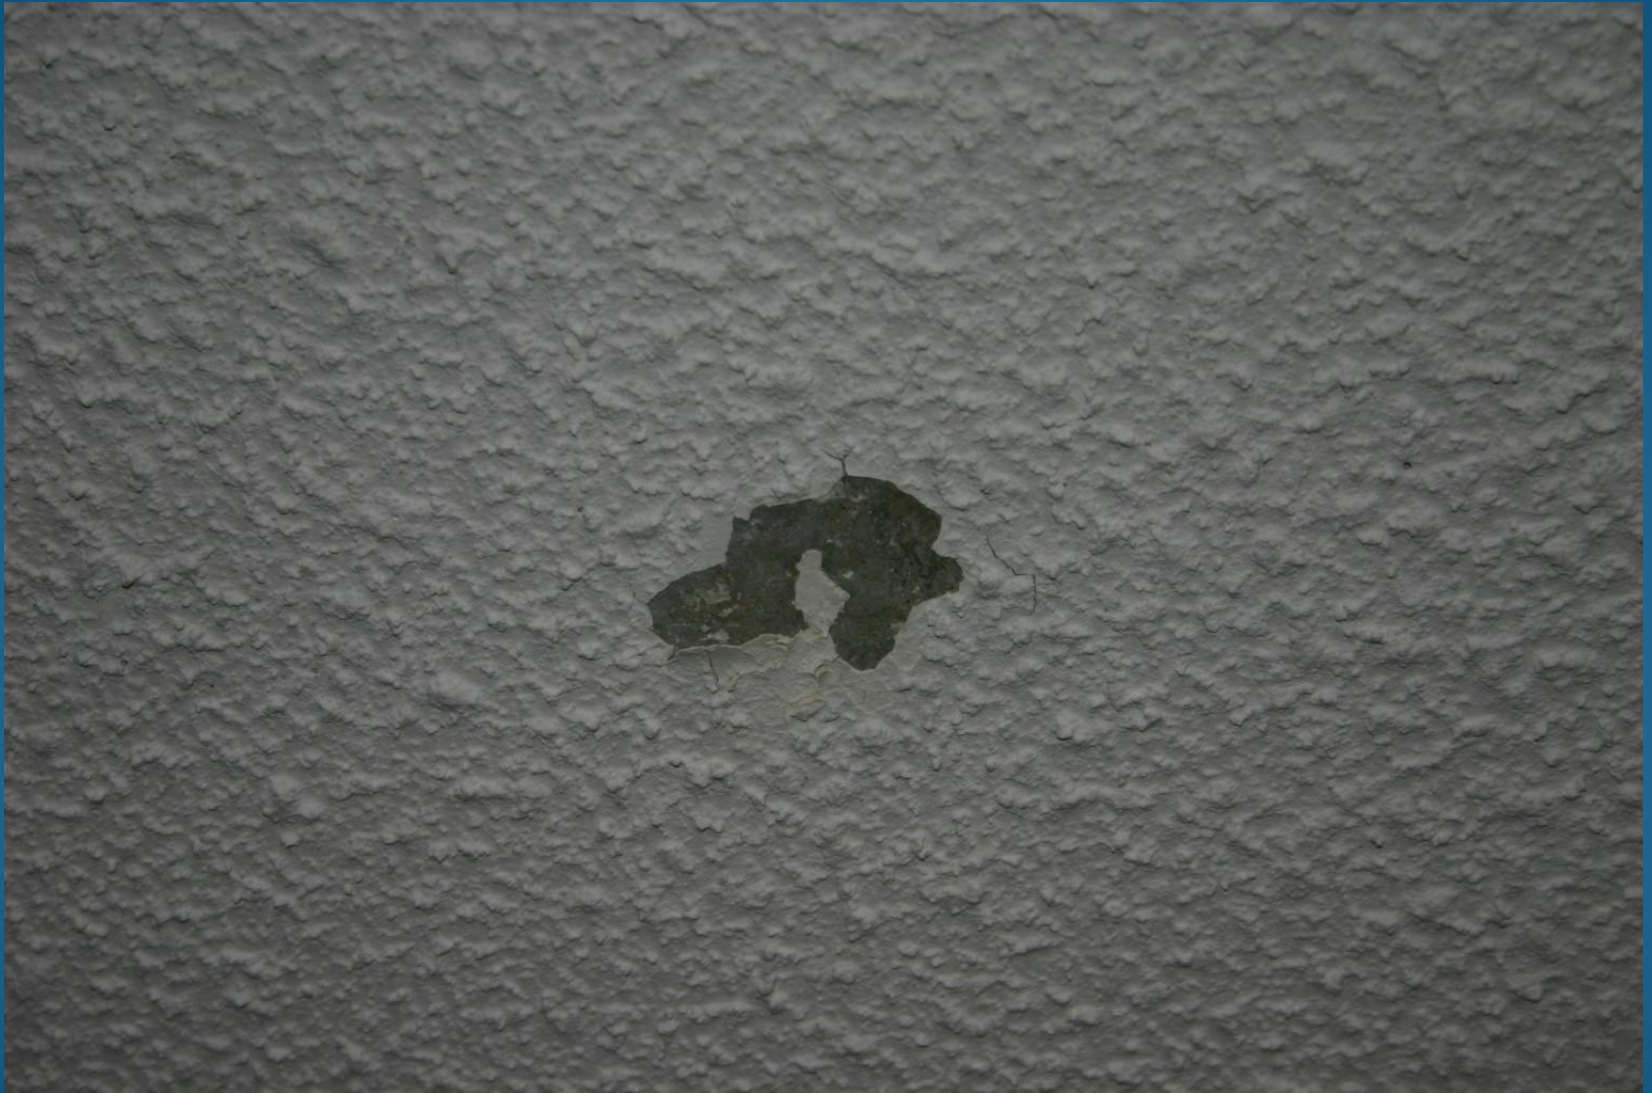
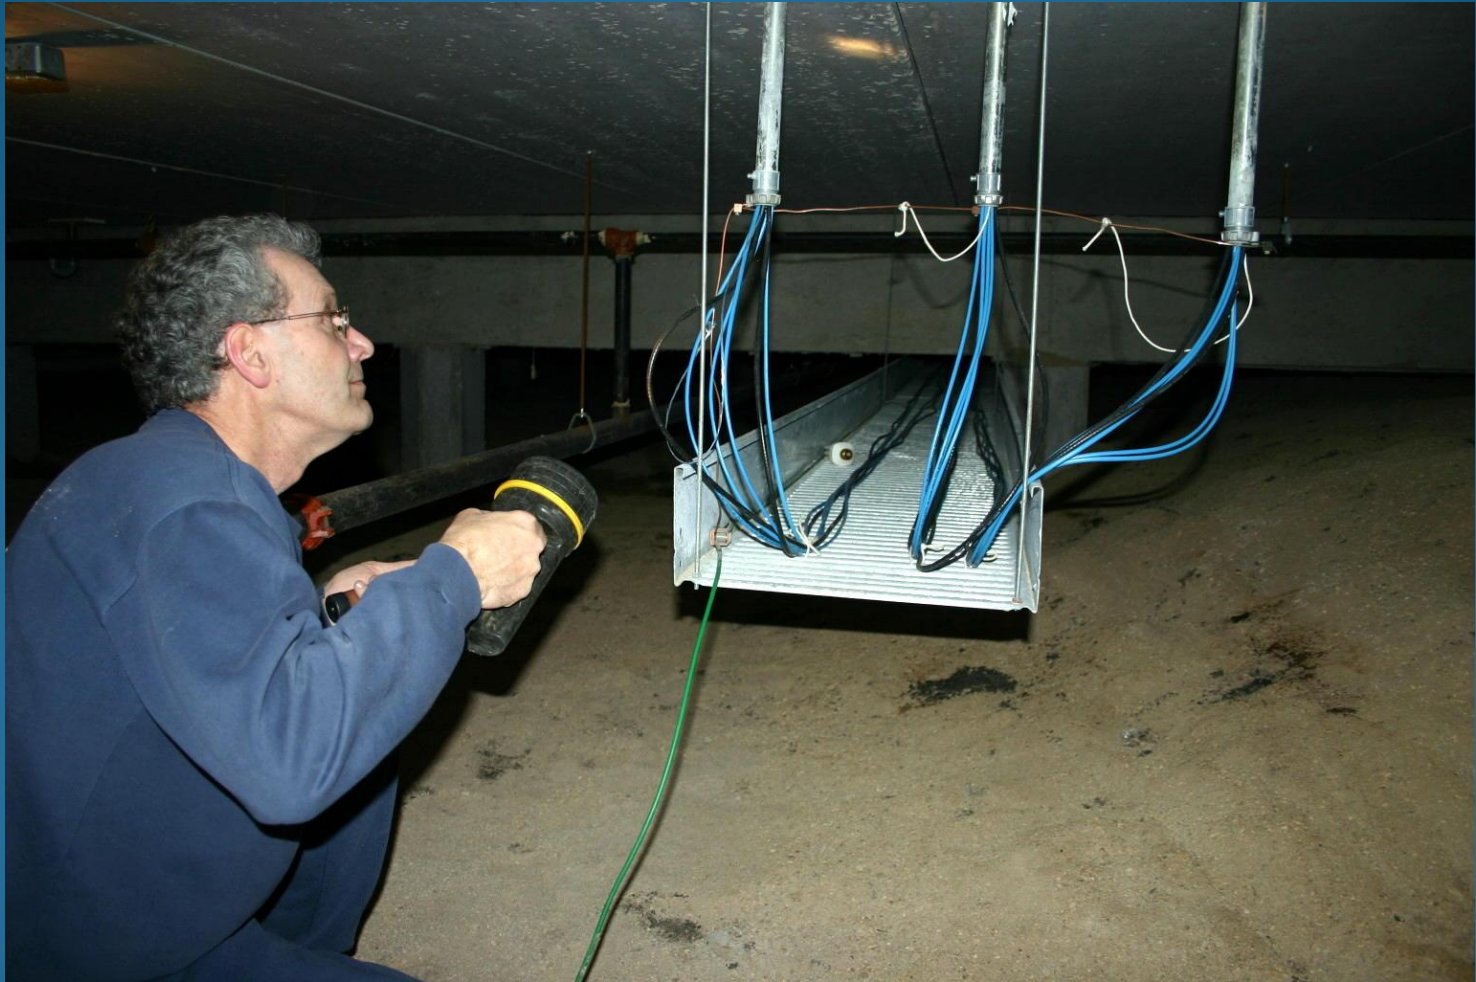
Analysis: an air leakage examination was conducted to determine if there could be a pathway from the crawl space to the interior of the hollow core slabs from which the floors were constructed.

Solution: fix the downspouts damaged by (drunken) persons unknown, repair the backdraft dampers damaged by (sober) squirrels and seal all openings in the crawl space (especially the wiring conduits).

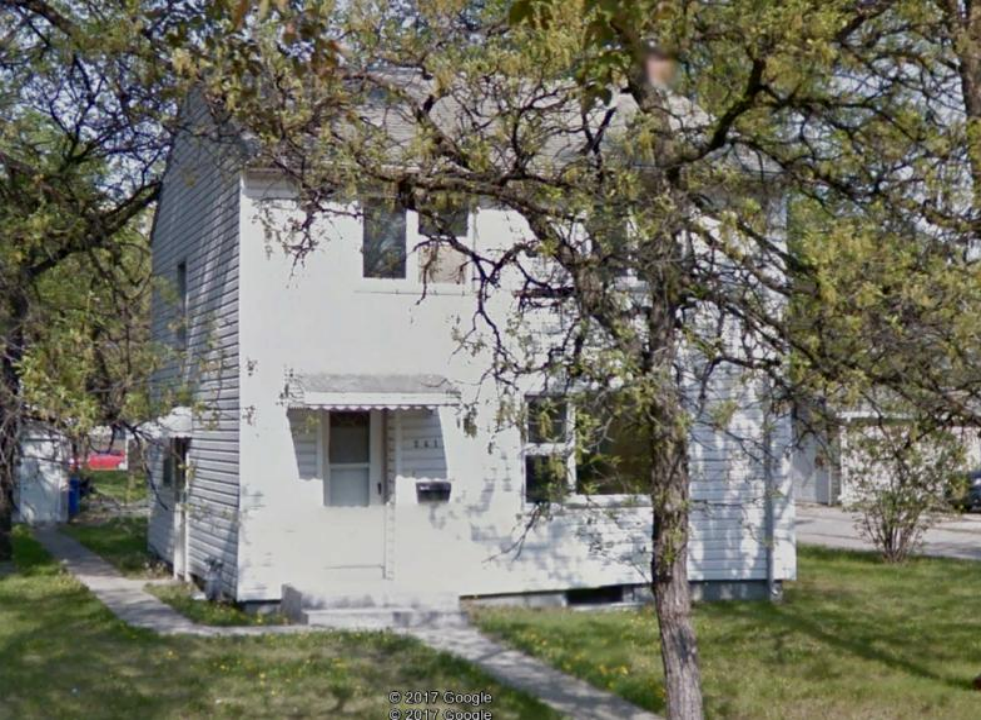
Before

For Example - The cost of repairing damage to existing sheathing ranged from \$5 to \$11 /m² (\$0.50 to \$1.00 /ft²), which represented 2% to 6% of the total wall retrofit cost.

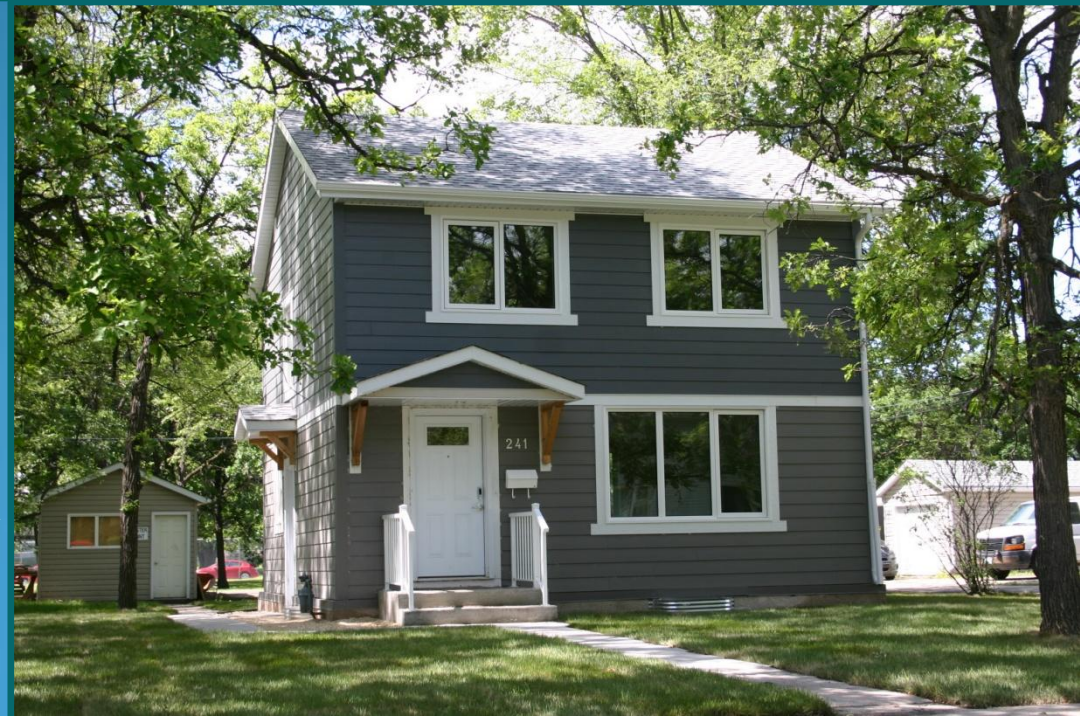
After

But With Proper Design & Construction, Moisture Damage Can Be Minimized
